Cisco DSAN System Troubleshooting Guide

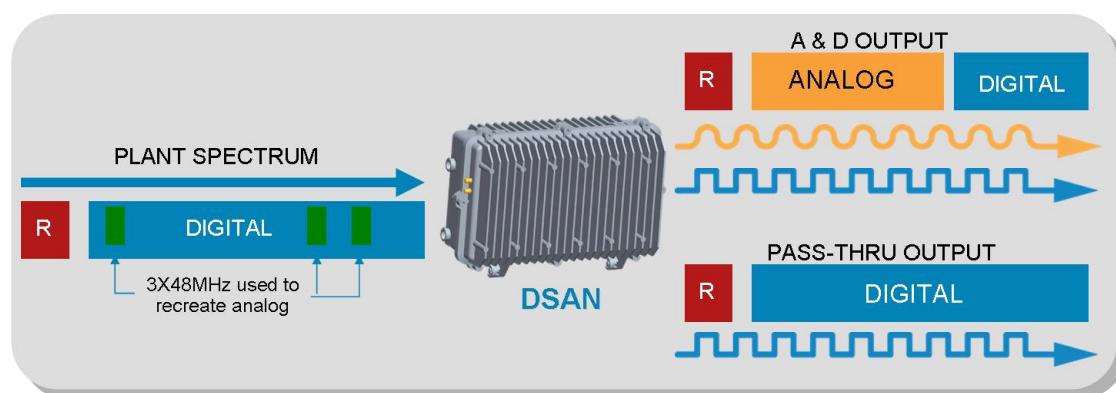
The DSAN is a device that converts a pure digital plant spectrum to a combined spectrum containing both digital and analog output, as shown in the following illustration.

The analog output is recreated from portions of the digital plant spectrum, and occupies the 54-to-552 MHz frequency range designated for CATV analog channels. The combined digital output (564 MHz to 1 GHz) is available for use by compatible receiving equipment such as a set-top box, EMTA, or cable modem.

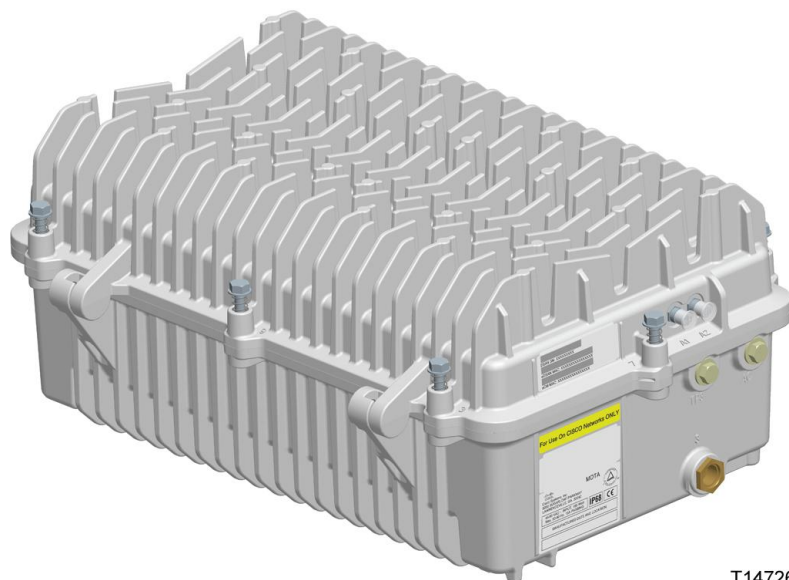
T14726

Physical Description

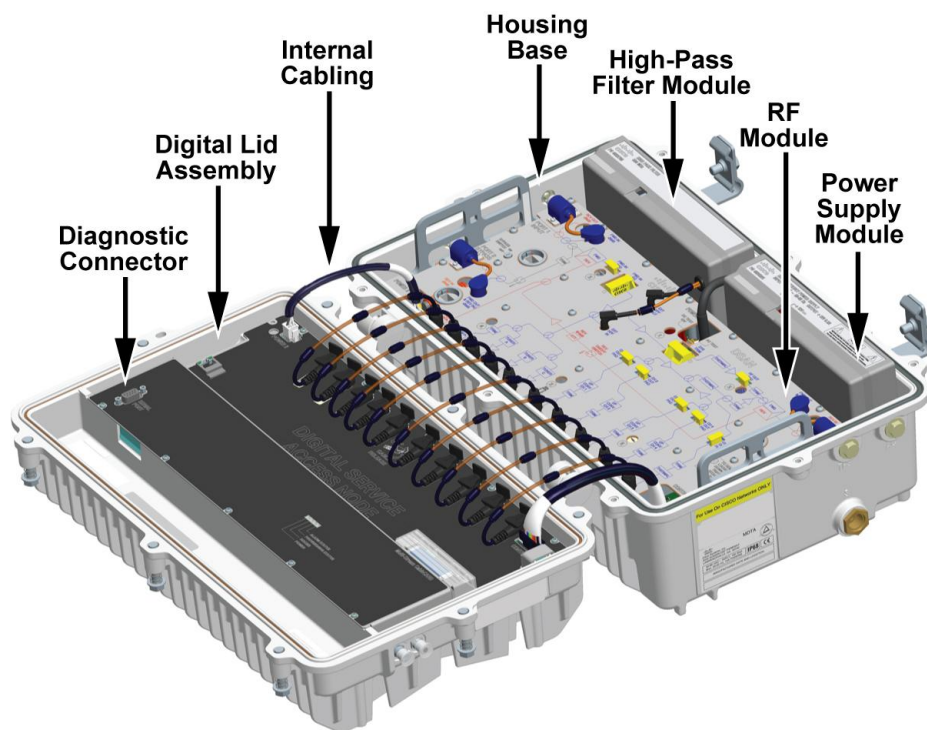
T14731

The DSAN system unit includes the following main internal components.

Component	Description
Housing base	Houses the high-pass filter, power supply, and RF module
RF module	Houses the RF tuners and upconverters and handles input and output signal routing
Power supply module	Converts coax line power to DC
Digital lid assembly	Houses the digital board
High pass filter module	Isolates regenerated analog from existing plant carriers
Internal cabling	1 power cable, 10 RF cables, 1 digital control cable
Diagnostic connector	Used for local management and troubleshooting

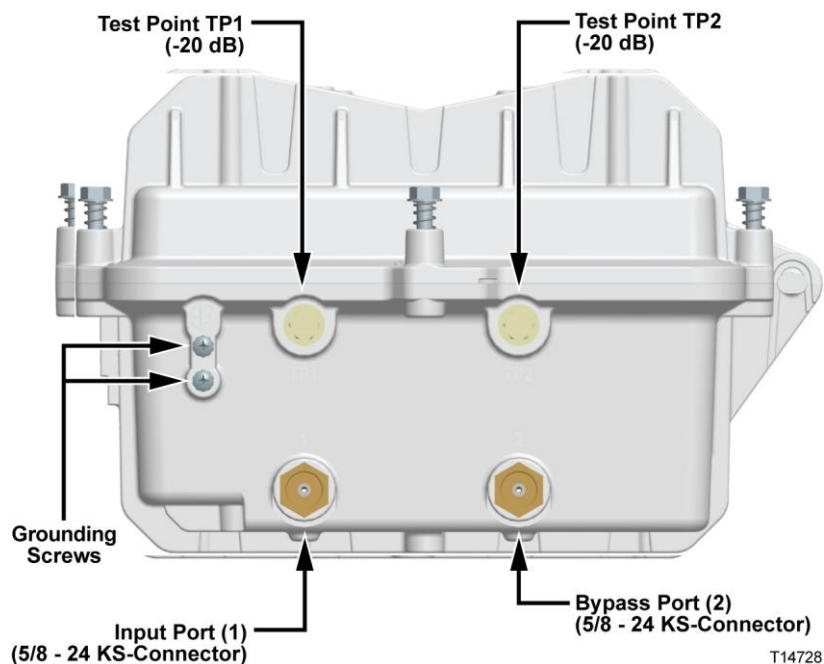
The left side of the enclosure contains the following connectors:

- Input port (Port 1)
- Bypass Output port (Port 2)
- Input forward path test point TP1 (-20 dB)
- Bypass Output forward path test point TP2 (-20 dB)

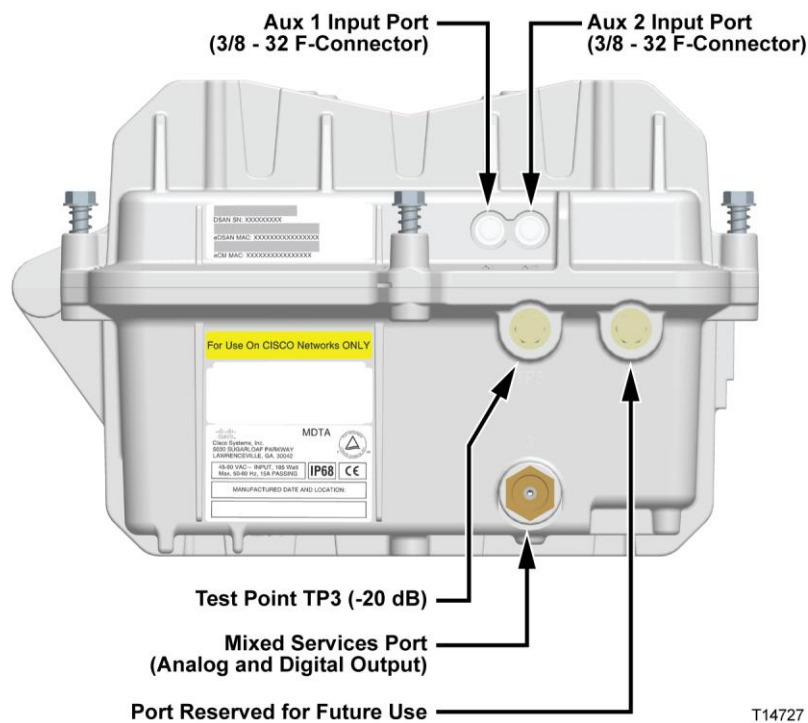
The right (product label) side of the DSAN enclosure contains the following connectors:

- Mixed Services output port (Port 3)
- Mixed Services output forward path test point TP3 (-20 dB)
- Aux 1 Input port
- Aux 2 Input port

An additional port next to the Mixed Services output port is reserved for possible future use.

Product labels are attached to the right side of the DSAN lid and base, as shown in the preceding illustration. These labels provide the following information.

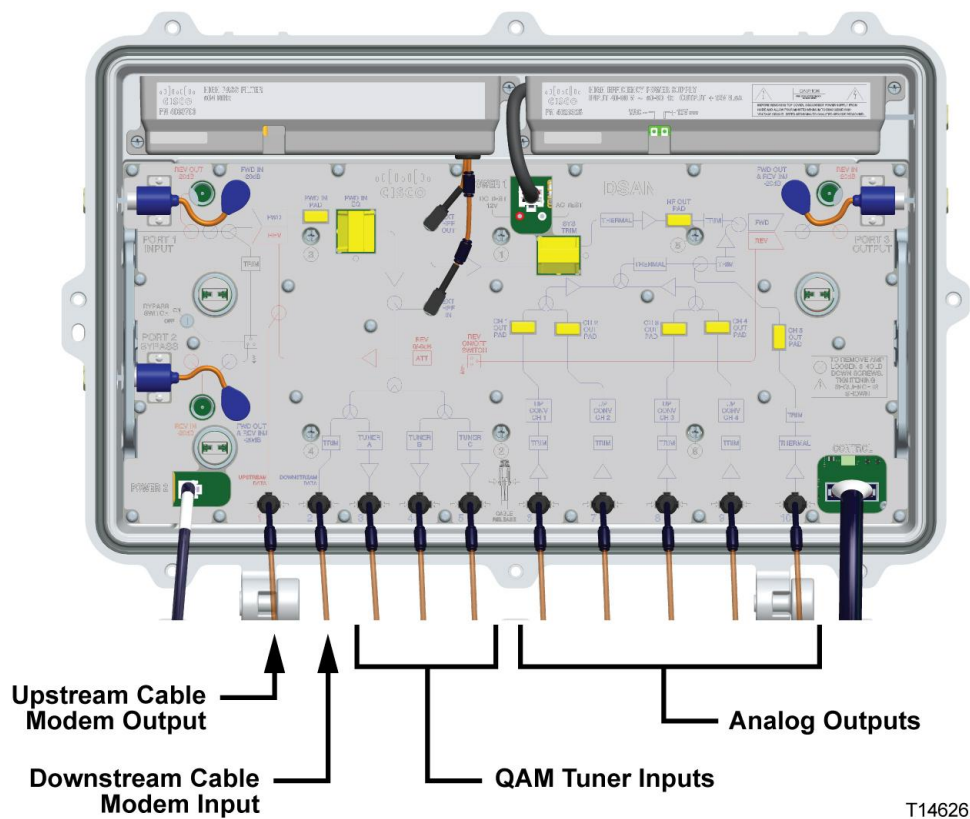
T14626

The DSAN receives quadrature amplitude modulated (QAM) MPEG-2 encoded video and AC3 encoded audio, and generates up to 82 NTSC video with BTSC audio channels between 54 MHz and 552 MHz.

All DSAN configurations have one coaxial input sourced from the service provider headend. The DSAN can tune up to three 48 MHz bands residing in the 88 MHz to 1 GHz spectrum. Residing within this 48 MHz band are eight contiguous 6 MHz QAM channels. Each QAM channel may contain up to 15 MPEG-2 video channels.

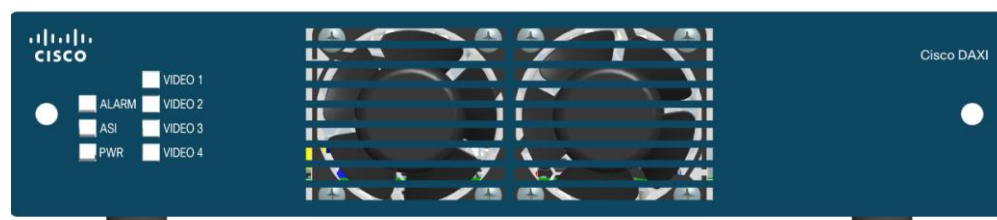
DAXI Front Panel

The DAXI accepts four analog baseband audio and video composite signal inputs, and provides one ASI output. The DAXI front panel has LEDs to show status on the four video inputs, the ASI output, the input power, and general Alarm status.

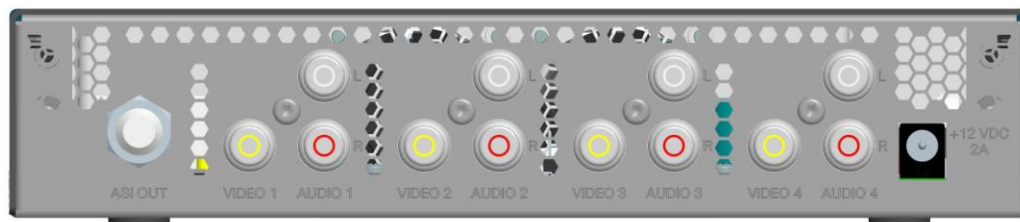
DAXI Back Panel

The DAXI accepts four analog baseband video composite signals over female RCA connectors, and their corresponding analog stereo baseband audio signals over female RCA connectors. On the data path side, it provides one standard ASI output on a female F connector. The DAXI is powered by 12 VDC via an external power supply converter.

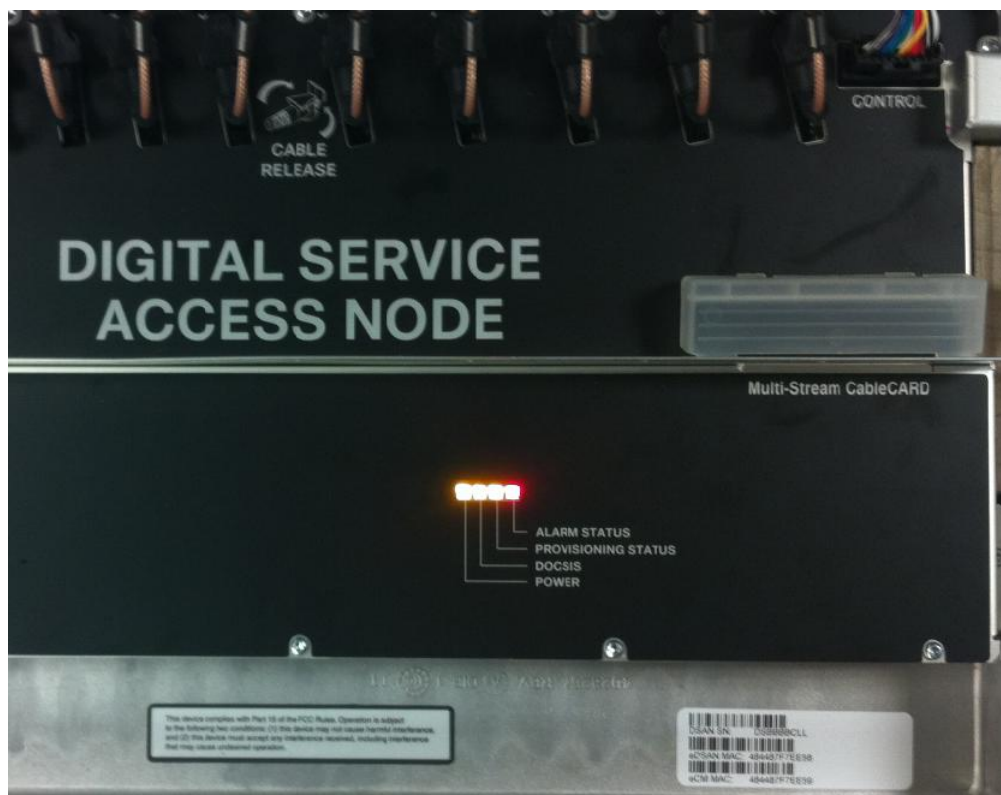
After connecting the plant coax to the DSAN Input port and applying power to the unit, open the DSAN housing and verify that the power LED on the digital board is illuminated, as shown in the following illustration.

If the power LED is not illuminated:

- Use a digital multimeter (DMM) to check for the correct incoming AC or DC voltages.
- If incoming AC or DC voltage is not correct, check for power at the test lugs on the power supply module.
- If the power supply tests OK, probe the RF module itself for power. If power is not reaching the RF module, check for a loose or broken cable.

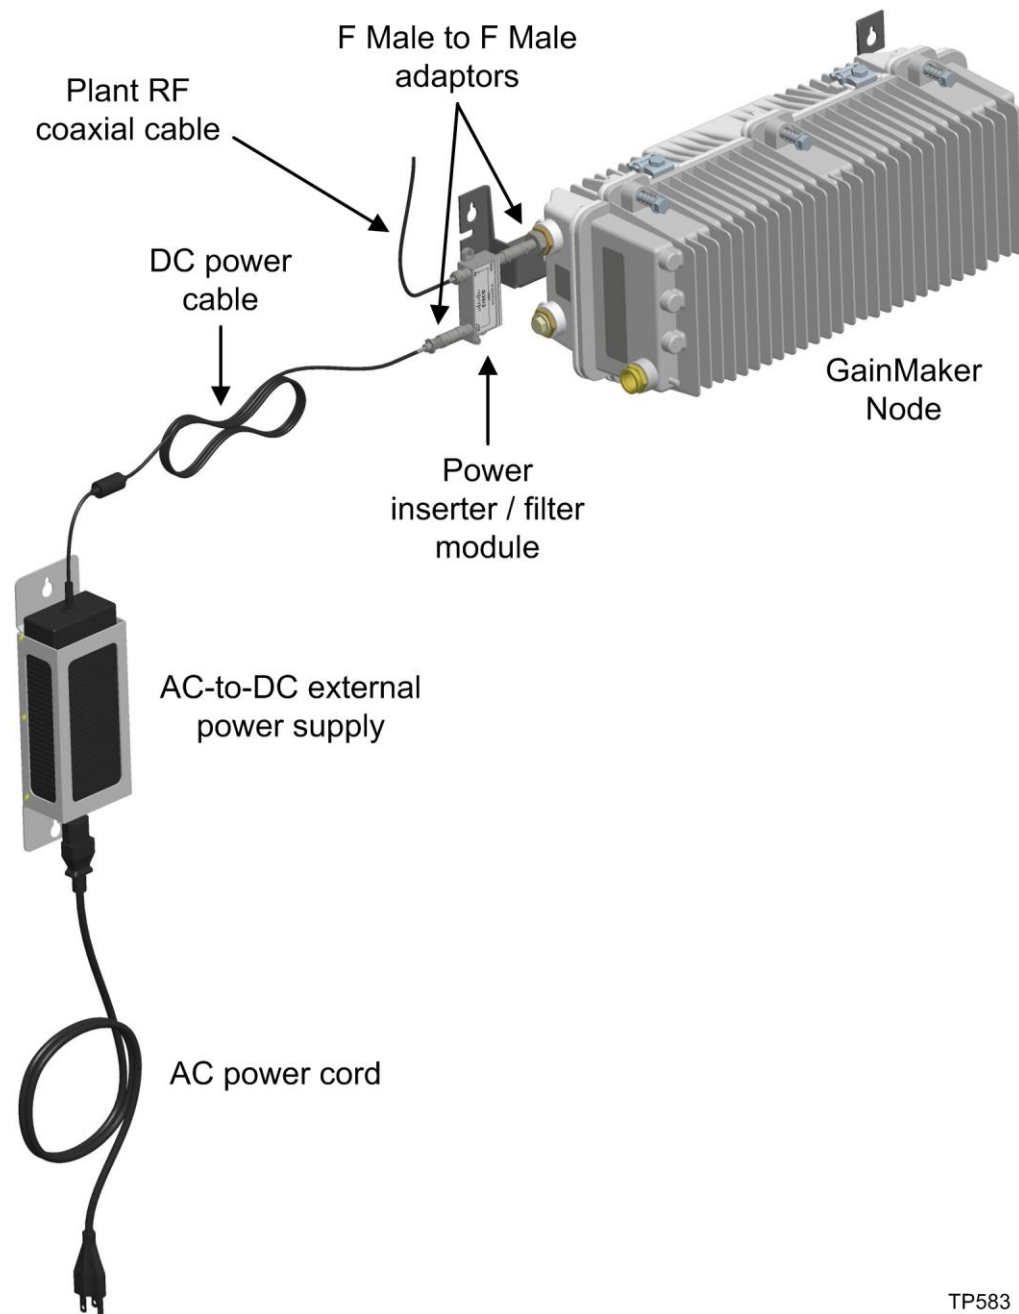
TP583

Connect the Mains Power Supply as shown in the following illustration. (Substitute the DSAN for the GainMaker in the picture.)

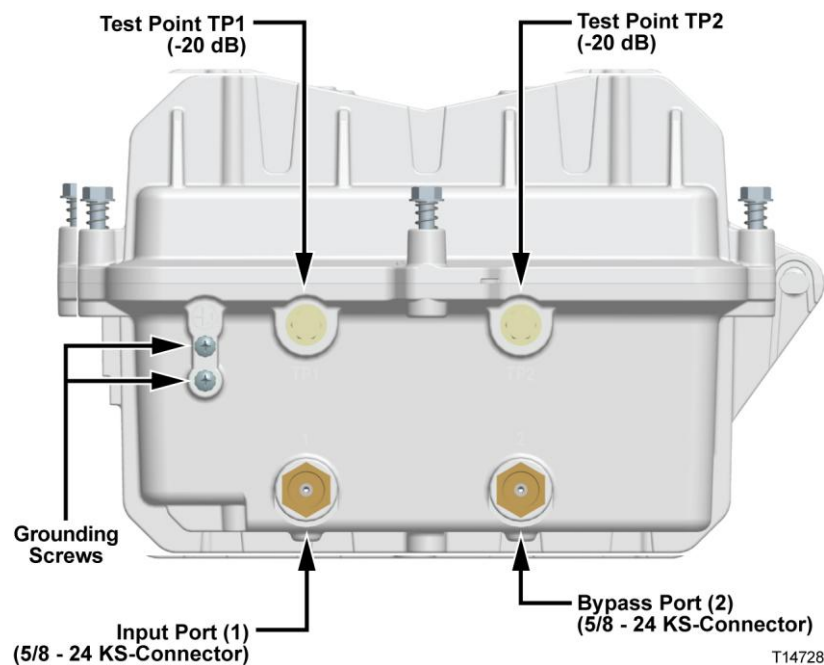
- 1 Connect the cable plan to the Input port (Port 1) on the DSAN unit.
- 2 Connect the test equipment to the Input port test point (FWD IN -20dB TP) on the DSAN unit.

- 3 Measure the signal levels at the lowest frequency and highest frequencies specified in the system design.
- 4 Adjust the FWD IN EQ to flatten the frequency spectrum. Adjust the FWD IN PAD to adjust the level of the input signals.

Note: A FWD IN PAD value of 1 dB and a FWD IN EQ value of 0 dB give the proper setup for a flat input spectrum with digital signal levels at +4 dBmV (analog channels are + 10 dBmV, or 6 dB higher than digital). Changes in the FWD IN PAD and FWD IN EQ values will not change the measured results at the FWD IN -20 dB test point because this test point is located ahead of the input accessories.

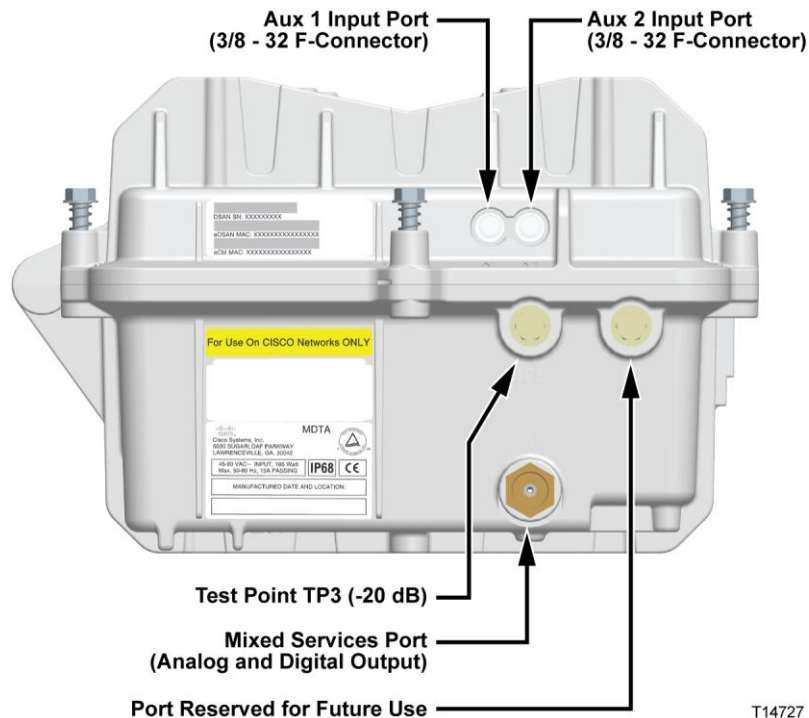
- 5 Connect the test probe to the Mixed Services output port (Port 3) test point (FWD OUT -20 dB TP3).

After power is applied, the DSAN takes about 4 minutes to boot completely. No analog channels are present at this step until the unit has booted completely.

- 6 Monitor the output levels of all active channels between 585 MHz and the upper frequency limit of the plant.
 - a Note the highest and lowest signal levels over that frequency range.
 - b Add together the highest and lowest signal levels noted above, and then divide the result by 2.
 - c Use the resulting average value as the reference digital channel signal level.
- 7 Measure and note the output signal level of Channel 2 (55.25 MHz) at the Mixed Services output port (Port 3) test point (FWD OUT -20 dB TP). Use this value as the reference analog channel signal value for the next step.

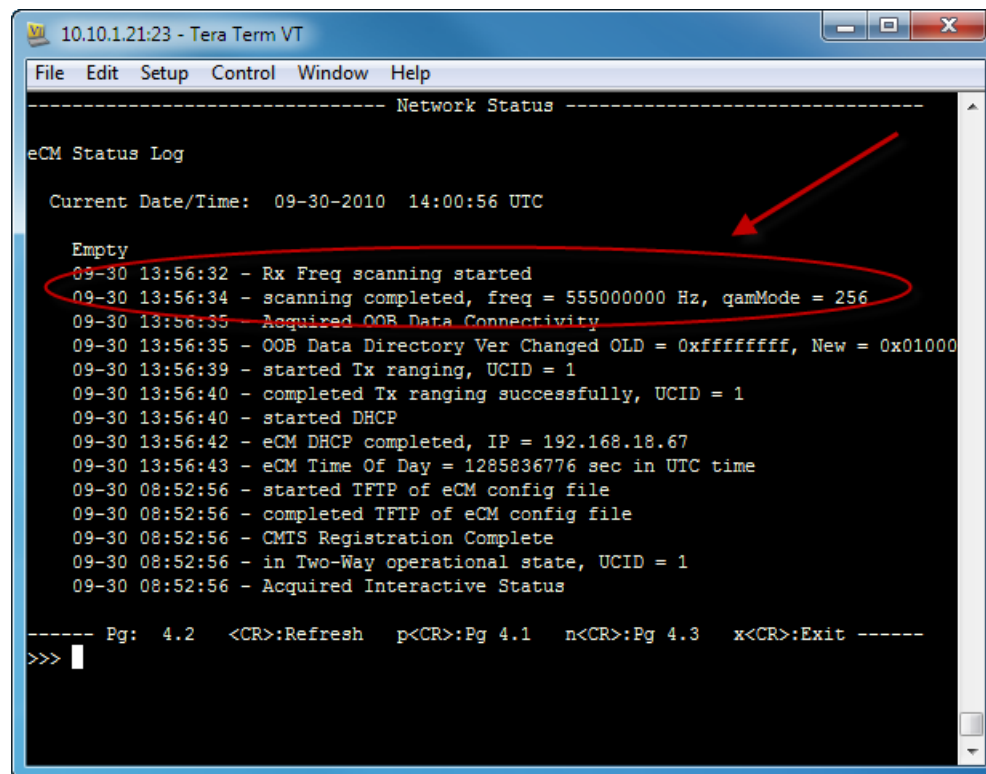
Review CLI diag page 4.2 to confirm that frequency scanning completed successfully.

```
10.10.1.21:23 - Tera Term VT
File Edit Setup Control Window Help
----- Network Status -----
eCM Status Log
Current Date/Time: 09-30-2010 14:00:56 UTC
Empty
09-30 13:56:32 - Rx Freq scanning started
09-30 13:56:34 - scanning completed, freq = 555000000 Hz, qamMode = 256
09-30 13:56:35 - Acquired OOB Data Connectivity
09-30 13:56:35 - OOB Data Directory Ver Changed OLD = 0xffffffff, New = 0x01000
09-30 13:56:39 - started Tx ranging, UCID = 1
09-30 13:56:40 - completed Tx ranging successfully, UCID = 1
09-30 13:56:40 - started DHCP
09-30 13:56:42 - eCM DHCP completed, IP = 192.168.18.67
09-30 13:56:43 - eCM Time Of Day = 1285836776 sec in UTC time
09-30 08:52:56 - started TFTP of eCM config file
09-30 08:52:56 - completed TFTP of eCM config file
09-30 08:52:56 - CMTS Registration Complete
09-30 08:52:56 - in Two-Way operational state, UCID = 1
09-30 08:52:56 - Acquired Interactive Status
----- Pg: 4.2 <CR>:Refresh p<CR>:Pg 4.1 n<CR>:Pg 4.3 x<CR>:Exit -----

Note: If the Cisco CA client ID is not specified in the DCD, the eCM will continue to search for a CMTS downstream channel that has it. This error is indicated by a "downstream scanning completed" message on diag page 4.0 but a "Rx freq scanning failed" message on diag page 4.2 If this error occurs, contact your CMTS administrator for assistance.

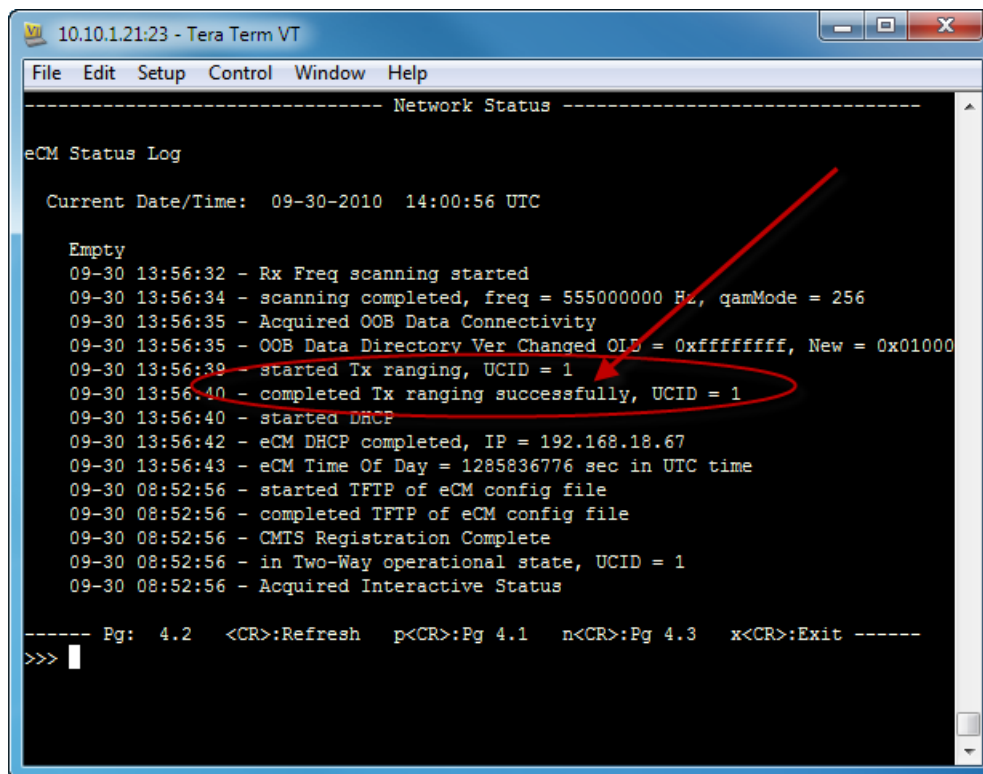
Successful completion of upstream ranging is reported on CLI diag page 4.2, as shown in the following example.

If there is too much loss in the reverse path, ranging will fail and the eCM will default to one-way operation. You can correct this by reducing the loss of your plant upstream of the DSAN input.

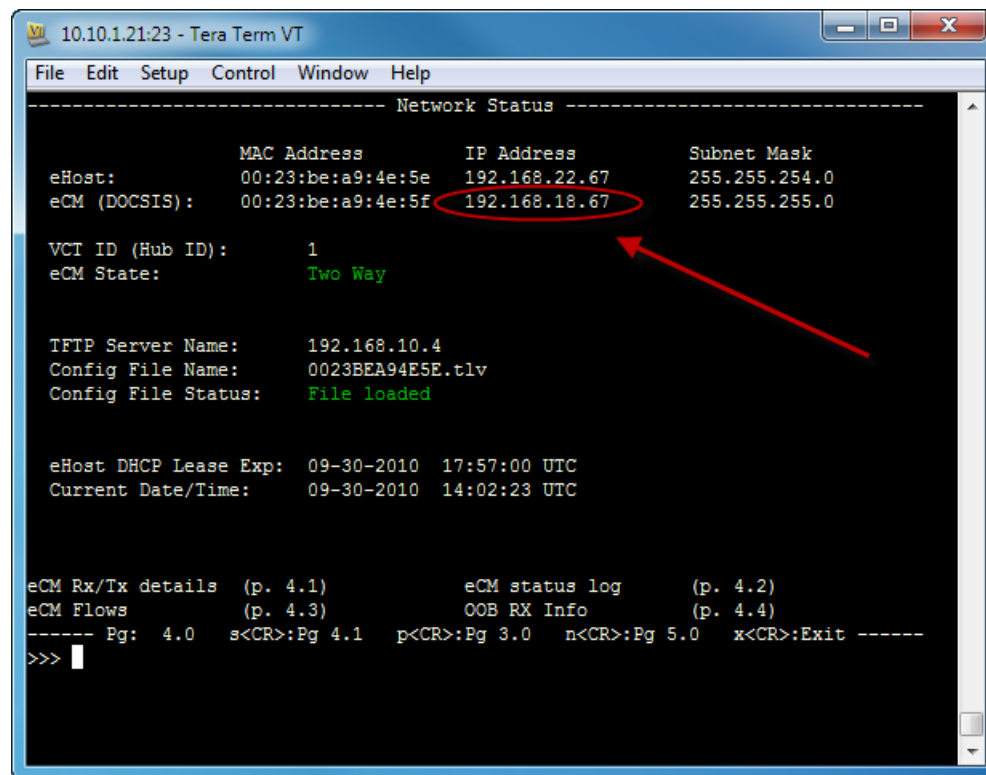
After ranging has succeeded, the eCM tries to obtain an IP address using DHCP. You can verify the IP address on CLI diag page 4.0, as shown in the following example.

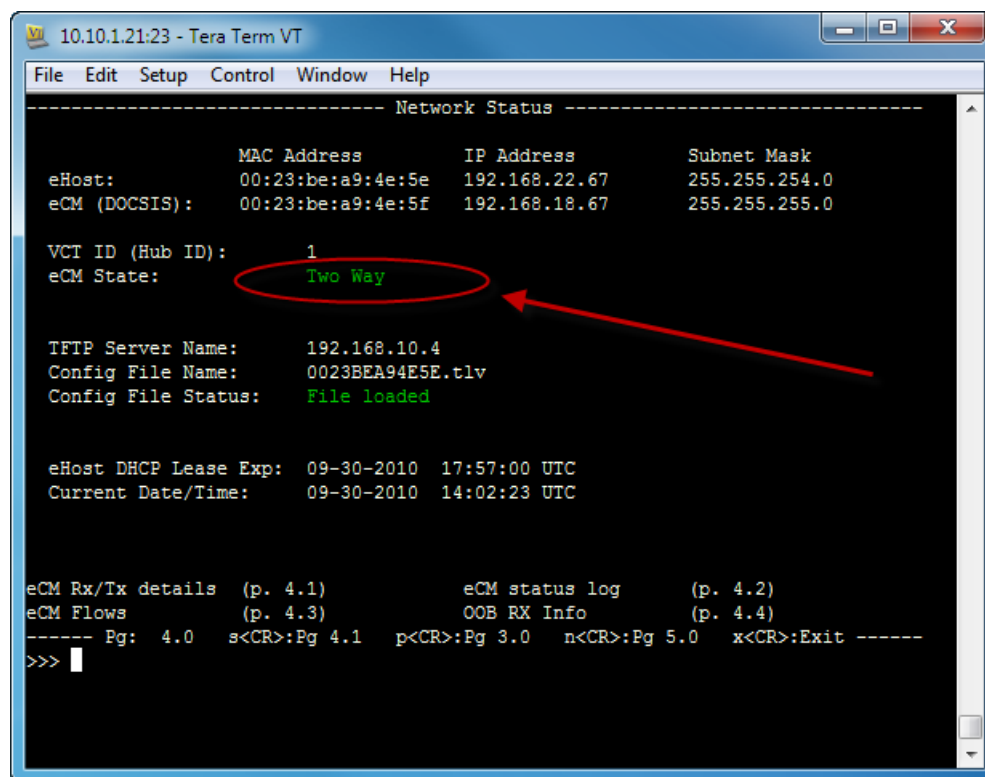
Once an IP address is established, the eCM will enter two-way operation. Two-way operation is reported on CLI diag page 4.0, as shown in the following example.

The screenshot shows a Tera Term VT window with the title "10.10.1.21:23 - Tera Term VT". The window displays a network status report. A red circle highlights the "Two Way" status of the eCM, with a red arrow pointing to it from the right. The report includes details about the eHost, eCM (DOCSIS), VCT ID, TFTP Server Name, Config File Name, Config File Status, eHost DHCP Lease Exp, and Current Date/Time. At the bottom, there are links to various diagnostic pages (Pg 4.0, Pg 4.1, Pg 3.0, Pg 5.0) and an Exit option.

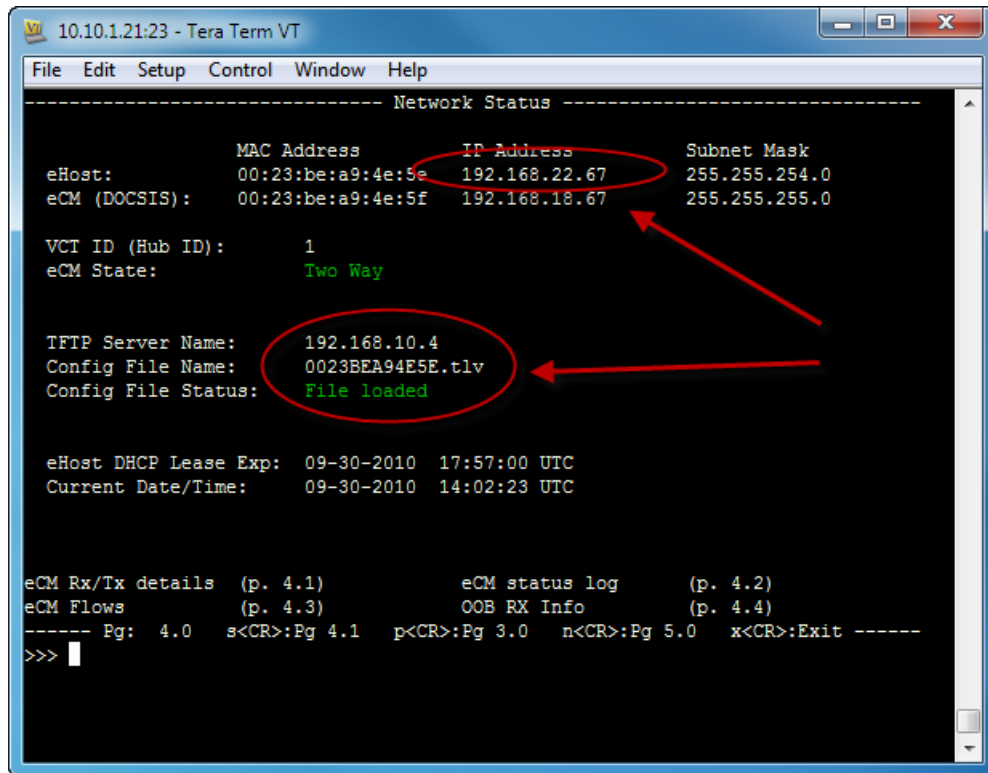
The TFTP server is used to get the eHost configuration file for the DSAN. You can verify acquisition of the config file on CLI diag page 4.0, as shown in the following example.

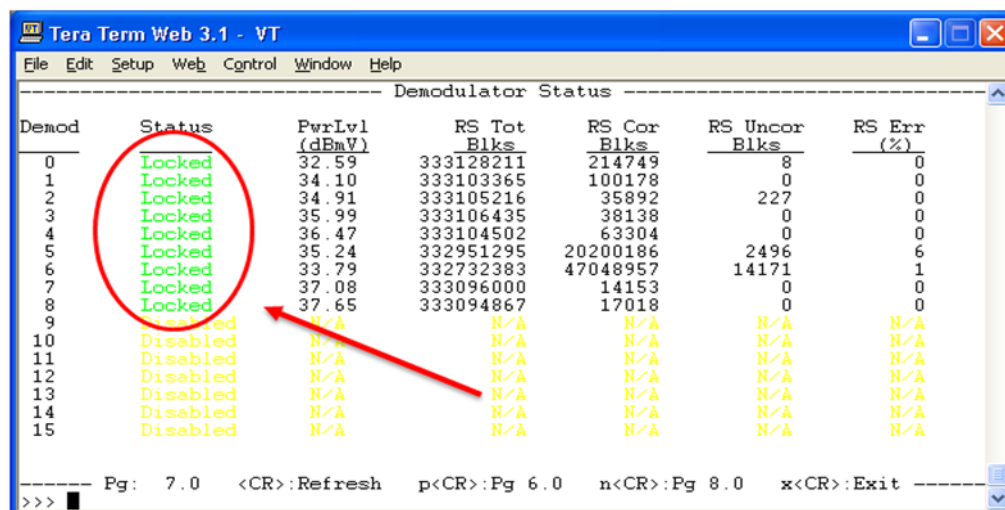
Demod	Status	PwrLvl (dBmV)	RS Tot Blks	RS Cor Blks	RS Uncor Blks	RS Err (%)
0	Locked	32.59	333128211	214749	8	0
1	Locked	34.10	333103365	100178	0	0
2	Locked	34.91	333105216	35892	227	0
3	Locked	35.99	333106435	38138	0	0
4	Locked	36.47	333104502	63304	0	0
5	Locked	35.24	332951295	20200186	2496	6
6	Locked	33.79	332732383	47048957	14171	1
7	Locked	37.08	333096000	14153	0	0
8	Locked	37.65	333094867	17018	0	0
9	Disabled	N/A	N/A	N/A	N/A	N/A
10	Disabled	N/A	N/A	N/A	N/A	N/A
11	Disabled	N/A	N/A	N/A	N/A	N/A
12	Disabled	N/A	N/A	N/A	N/A	N/A
13	Disabled	N/A	N/A	N/A	N/A	N/A
14	Disabled	N/A	N/A	N/A	N/A	N/A
15	Disabled	N/A	N/A	N/A	N/A	N/A

Important: Do not use the PwrLvl column on this page for absolute power measurements of any kind. Engineering has noted that a reading of < 29 dBmV indicates that an issue is present.

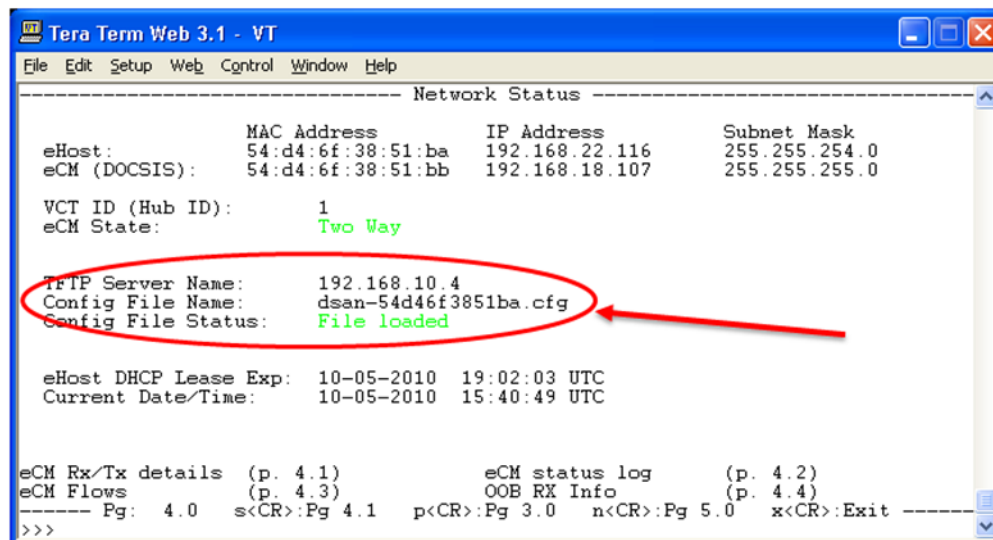
A corrupt configuration file alarm results when the config file received from the headend is invalid, probably due to failure of the SHA1 checksum validation.

You can check the status of the configuration file on CLI diag page 4.0, as shown in the following example.

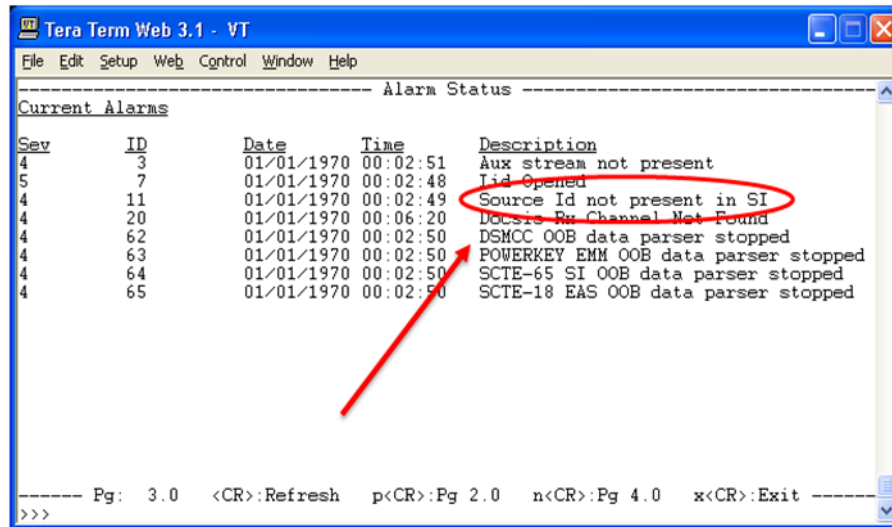
This alarm is triggered when the QAM mode is unknown, or when the source ID is not present in the SI. This alarm appears in the CLI diag pages as shown in the following example.

```
Tera Term Web 3.1 - VT
File Edit Setup Web Control Window Help
----- Alarm Status -----
Current Alarms
Sev    ID    Date      Time      Description
4      3      01/01/1970 00:02:51 Aux stream not present
5      7      01/01/1970 00:02:48 Lid Opened
4      11     01/01/1970 00:02:49 Source Id not present in SI
4      20     01/01/1970 00:06:20 DotSis Rx Channel Not Found
4      62     01/01/1970 00:02:50 DSMCC OOB data parser stopped
4      63     01/01/1970 00:02:50 POWERKEY EMM OOB data parser stopped
4      64     01/01/1970 00:02:50 SCTE-65 SI OOB data parser stopped
4      65     01/01/1970 00:02:50 SCTE-18 EAS OOB data parser stopped

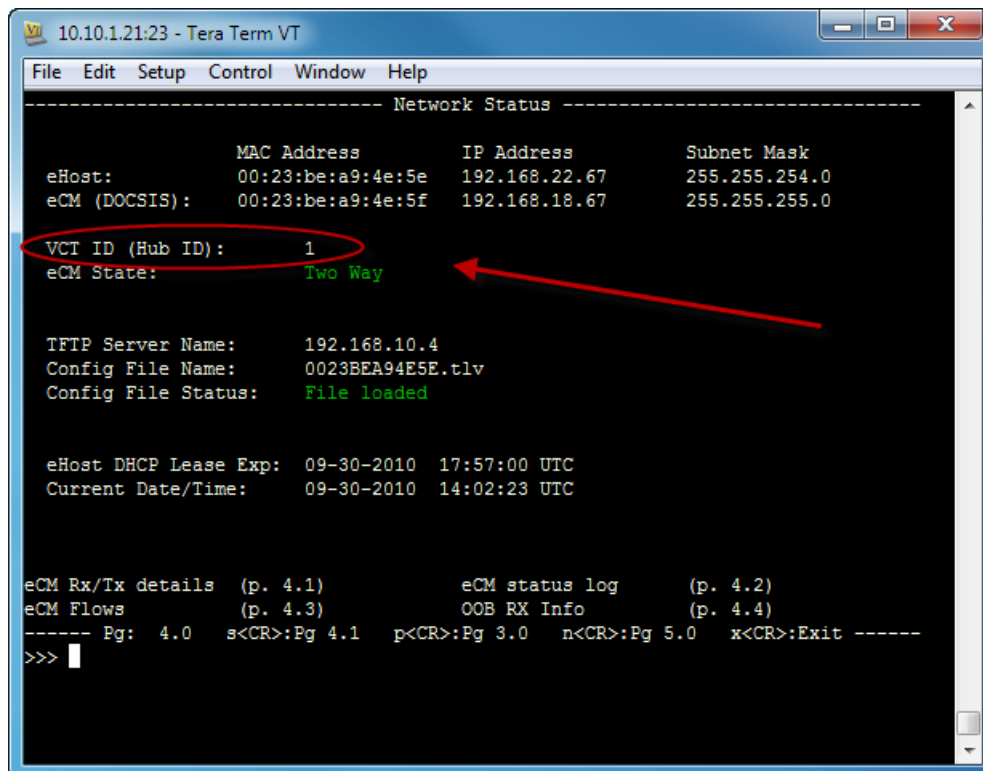
In the event of a **VCTID not in configuration file** error, check CLI diag page 4.0 to see if the DSAN has the proper Hub ID, as shown in the following example. The DSAN must have a valid Hub ID in order to parse SI data.

```
10.10.1.21:23 - Tera Term VT
File Edit Setup Control Window Help
----- Network Status -----
eHost:          MAC Address      IP Address      Subnet Mask
eCM (DOCSIS):   00:23:be:a9:4e:5e 192.168.22.67   255.255.254.0
eCM (DOCSIS):   00:23:be:a9:4e:5f 192.168.18.67   255.255.255.0
VCT ID (Hub ID): 1
eCM State:      Two Way

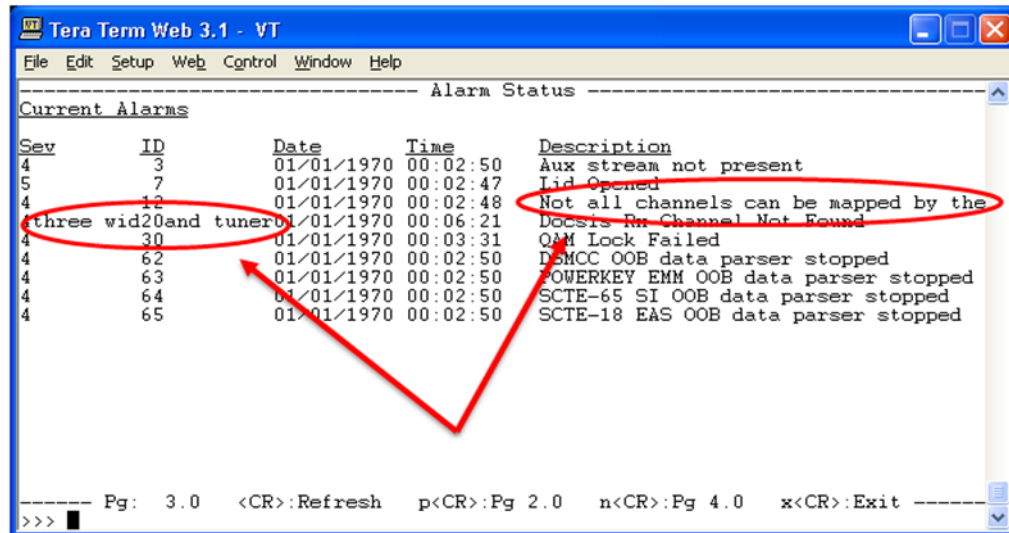
An alarm may appear stating that not all channels can be mapped by the three wideband tuners. This alarm is triggered when the channel lineup does not fit within the contiguous 48 MHz bandwidth of the three wide-band tuners. The alarm appears as shown in the following example.

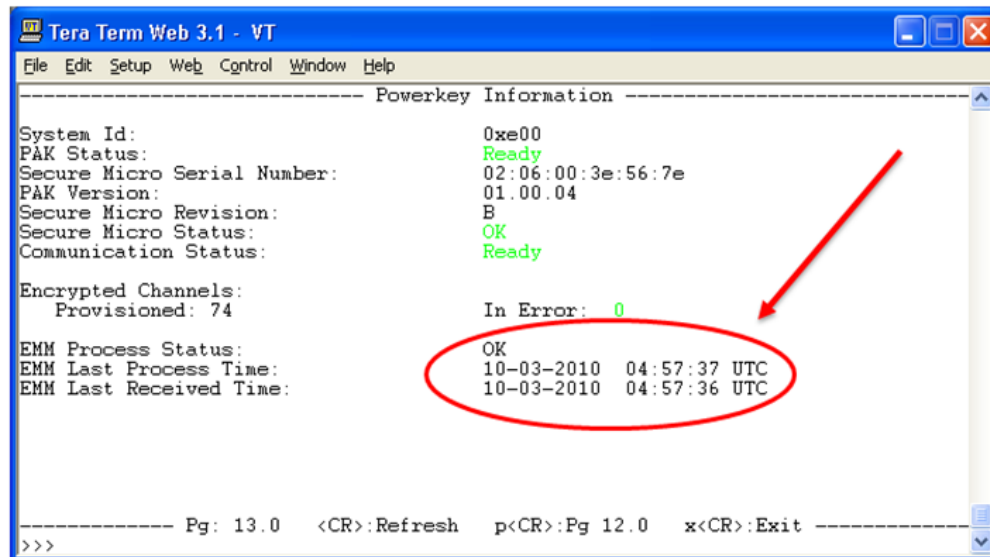
If the EMM has expired, send an “Instant Hit” to the unit as shown in the following example.
