Prisma II HDTx RF Input Power -6 dB Offset Technical Bulletin

The purpose of this document is to inform Prisma II™ High Density Transmitter (HDTx) users of a possible issue in which the RF input power indicated on the LCI or ICIM is 6 dB below the actual power level.

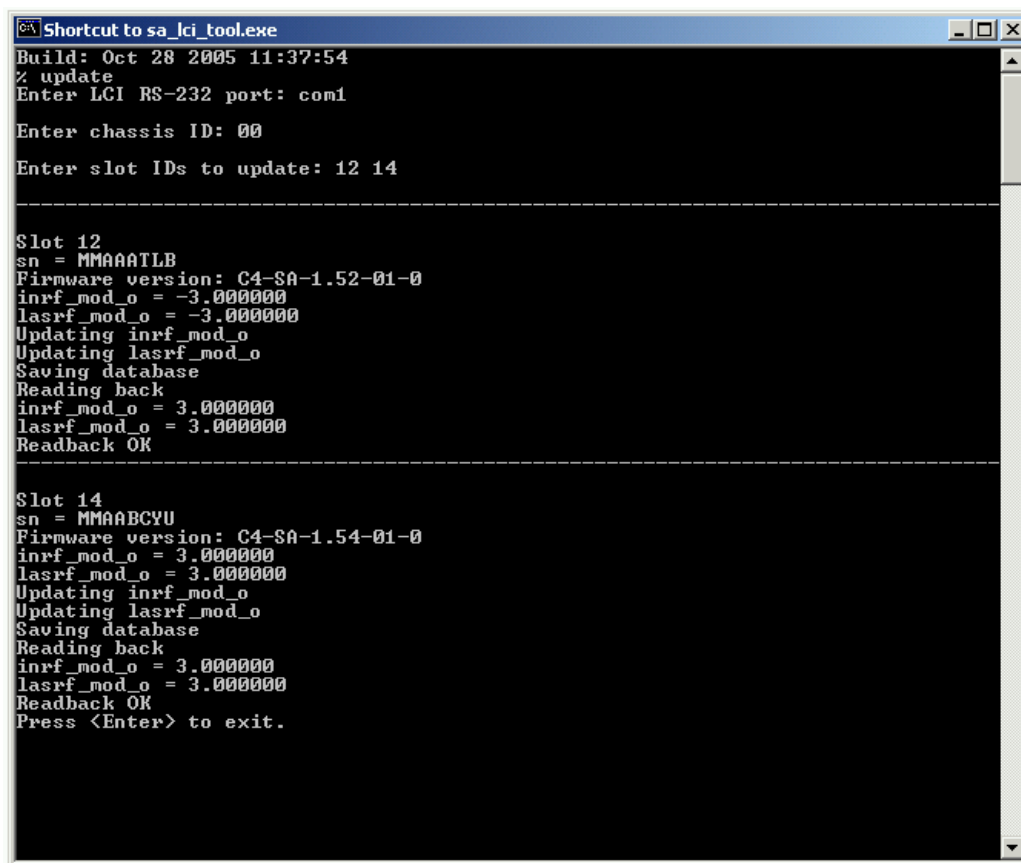
Software Update Procedure

An example of the update program in operation is shown below.

```
Shortcut to sa_lci_tool.exe
Build: Oct 28 2005 11:37:54
% update
Enter LCI RS-232 port: com1
Enter chassis ID: 00
Enter slot IDs to update: 12 14
