# Prisma II High Density Transmitter Intermittent Video Flash or Alarm Technical Bulletin

This document informs users of Prisma II 1310 nm and QAM high density transmitters of possible intermittent failures with these modules, and explains how to perform a software update that resolves this issue.

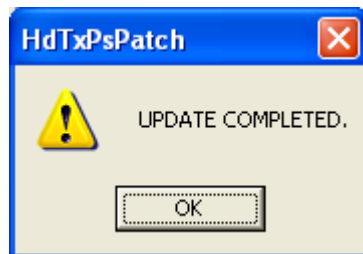
The following window pops up to indicate completion:

Click **OK** in this pop-up window to continue.

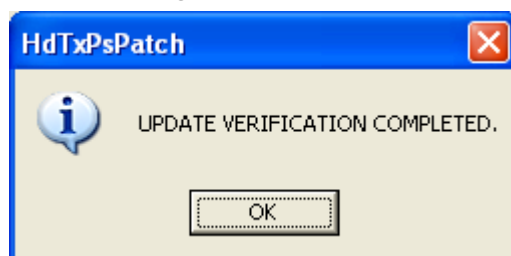
The following window pops up to indicate verification of the update:

Click **OK** in this pop-up window to complete the update.

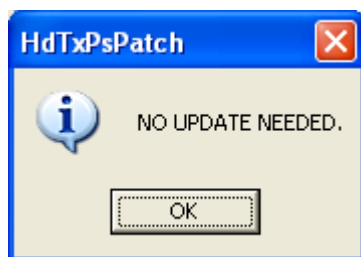
The following pop-up window also appears.

Click **OK** in this window to terminate the update utility.
