Troubleshooting a Mesh Network

This document addresses problems that can arise in a mesh network operating with Cisco 1500 (1505, 1510) and 1520 (1522, 1524) series mesh access points and a Cisco Wireless LAN Controller operating with Cisco Unified Wireless Software (CUWN) releases 4.1.19x. Suggested solutions to those problems are also provided.

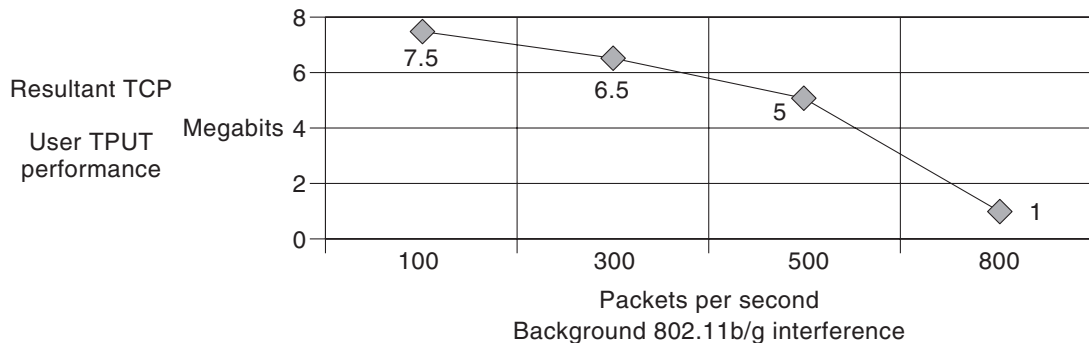
Figure 1 Transmission Control Protocol (TCP) Throughput vs. Channel Utilization

Additionally, Cisco WCS and the controller already have noise and interference feedback tools built-in to the controller AP monitor and WCS Report pages; in general, these tools display Pass or Fail results based on default criteria.
