# Release Notes for Cisco Aironet Access Points for Cisco IOS Release 12.3(11)JA1

**January 18, 2007**

This release is a maintenance release and contains no new features. These release notes list open and resolved caveats for Cisco IOS Release 12.3(11)JA1. They also provide important information about the Cisco Aironet 1130 and 1240 Series Access Points and 1300 Series Outdoor Access Point/Bridges.

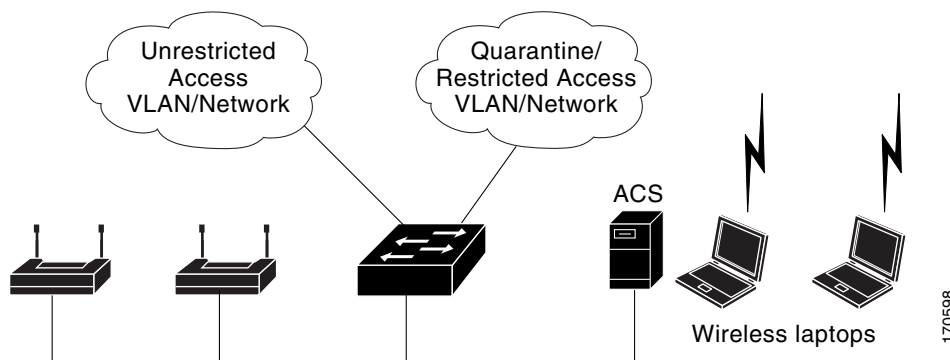
**Figure 4** Typical NAC Network Setup

Before you attempt to enable NAC for MBSSID on your access points, you should first have NAC working properly. [Figure 4](#) shows a typical network setup.

- 
- Step 1** Configure your network as shown in [Figure 4](#).
  - Step 2** Configure standalone access points and NAC-enabled client-EAP authentication.
  - Step 3** Configure the local profiles on the ACS server for posture validation.
  - Step 4** Configure the client and access point to allow the client to successful authenticate using EAP-FAST.
  - Step 5** Ensure that the client posture is valid.
  - Step 6** Verify that the client associates to the access point and that the client is placed on the unrestricted VLAN after successful authentication and posture validation.
-
