# Release Notes for Cisco Wireless LAN Controllers and Mesh Access Points for Release 4.2.207.54M

These release notes describe features, enhancements, and caveats in release 4.2.207.54M. This maintenance release supports Cisco 1500 (1505 and 1510) series outdoor mesh access points on the controller mainline release base.

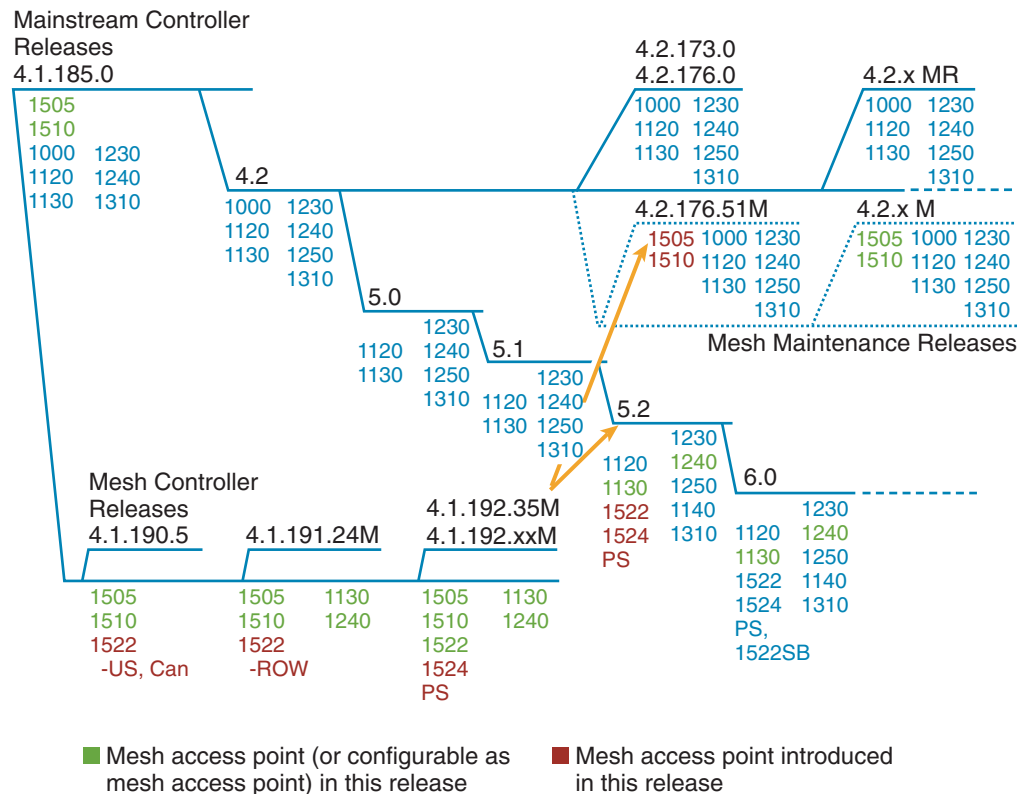
**Figure 1** Controller Mainstream and Mesh Releases

Release 4.2.207.54M provides support for Cisco 1500 (1505 and 1510) series outdoor mesh access points on the controller mainline release base (see [Figure 1](#)). The 1505 and 1510 **will not** be supported on any controller release beyond 4.2.

You can upgrade to this release from mesh release 4.1.192.35M.

1. Upgrading directly from release 4.1.192.35M to release 4.2.207.54M resets the controller to factory defaults. You should first upgrade from 4.1.192.35M to 4.2.176.51M and then to 4.2.207.54M.
2. You must be at release 4.1.192.35M to upgrade to release 4.2.176.51M.
3. You can upgrade directly from 4.1.190.5 to 4.1.192.35M; however, upgrading to 4.1.191.24M before upgrading to 4.1.192.35M is highly recommended.
4. Dynamic frequency selection (DFS) is not supported.
5. Release 4.0.217.204 provides fixes for DFS on the 1510. This functionality is only needed in countries where DFS rules apply.
