# Release Notes for Cisco Wireless LAN Controllers and Mesh Access Points for Release 4.1.192.22M

These release notes describe features, enhancements, and caveats in release 4.1.192.22M.

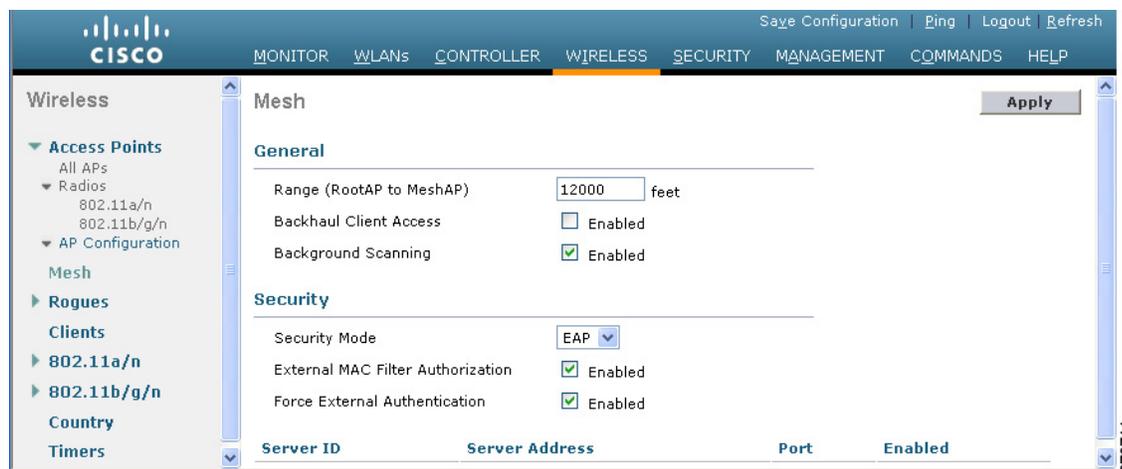
**Figure 1** Wireless > Mesh

- Step 1** In the controller GUI, click **Wireless > Mesh**. The mesh general and security window appears (Figure 1).

- Step 2** In the security section, select the **EAP** option from the Security Mode drop-down menu.
- Step 3** Check the **Enabled** check boxes for the External MAC Filter Authorization and Force External Authentication options.
- Step 4** Click **Apply**.
- Step 5** Click **Save Configuration**.

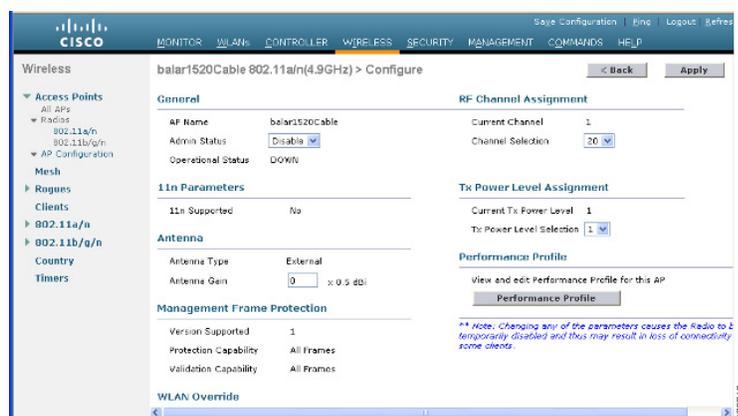
**Figure 2** *Wireless > Access Points > Radio > 802.11 a/n > Configure Window*

- Step 3** To assign the channel to use for the backhaul (channels 20 through 26), click **Wireless > Access Points > Radio** and select **802.11a/n** from the Radio sub-heading. A summary page for all 802.11a radios displays.
- Step 4** At the Antenna drop-down menu for the appropriate RAP, select **Configure**. The page seen in [Figure 2](#) displays.

- Step 5** At the RF Backhaul Channel Assignment section, select the **Custom** option for the Assignment Method option and select any channel between 1 and 26.
- Step 6** Click **Apply** to commit your changes.
- Step 7** Click **Save Configuration** to save your changes.
