Cisco TelePresence RMA Procedures for Cisco VCS and Cisco TelePresence Conductor Appliances

Reference Guide

Cisco VCS Cisco TelePresence Conductor

> D14887.05 December 2013

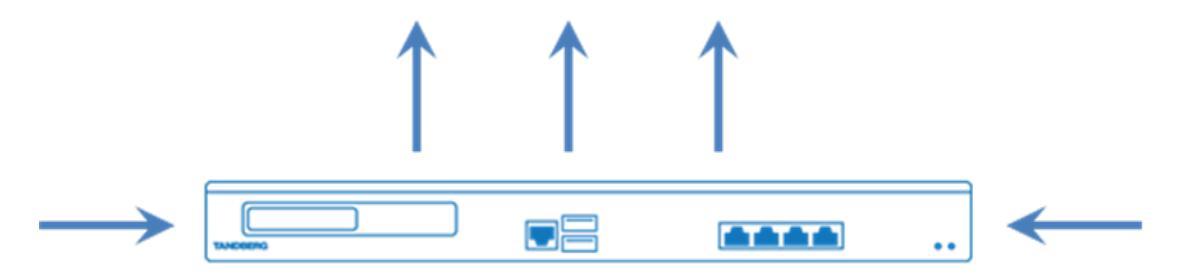
The unit has side air intakes and rear air exhaust. A check should be made to ensure there is sufficient ventilation, particularly at the sides. Even if the sides look OK another device (e.g. a CODIAN MCU) may be exhausting directly into the unit's air intake.

- Codian MCU airflow is from right to left, so be especially careful if racking them to the right of a VCS/TelePresence Conductor.
- Occasionally the thermistor temperature sensor may report a spurious reading. Acknowledge any alarm and monitor the system for further occurrences.
- Collect the proof of failure from the system as shown in Logs and evidence [p.9]
 - Alarms and warnings
 - Physical evidence

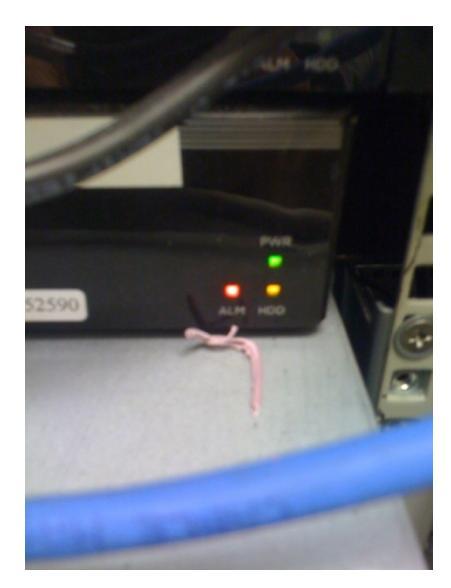
Alarm LED lit:

Any camera phone videos of procedures being carried out or pictures of monitor output, the LEDs, LCD and network link light display, such as the following examples are very useful in helping find the root cause for an RMA:

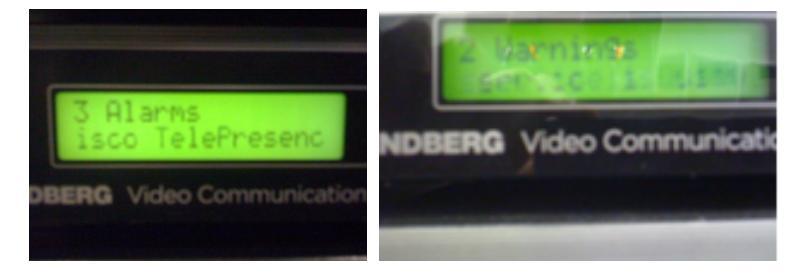
LCD text:
